Partition Separation Prevention and Solutions

Wood Truss Council of America

An informational series designed to address the issues and questions faced by professionals in the building construction process.

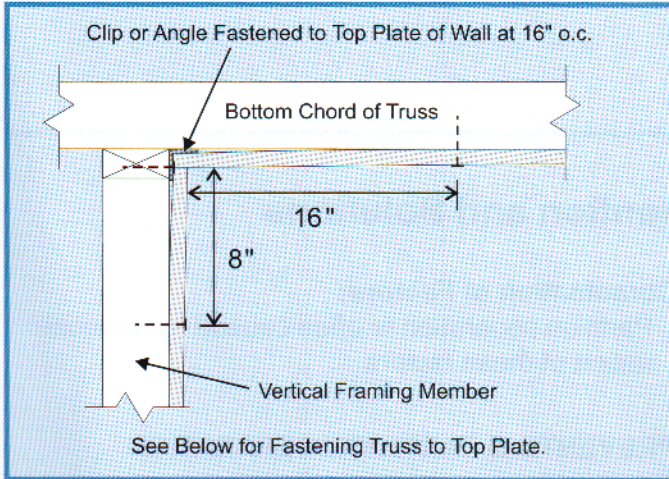
Floating Gypsum Corner I
(Truss Perpendicular to Wall)

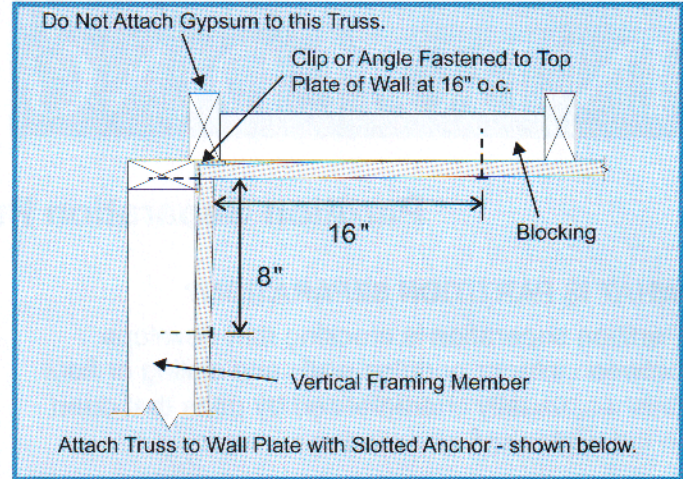
Floating Gypsum Corner II
(Truss Parallel to Wall)

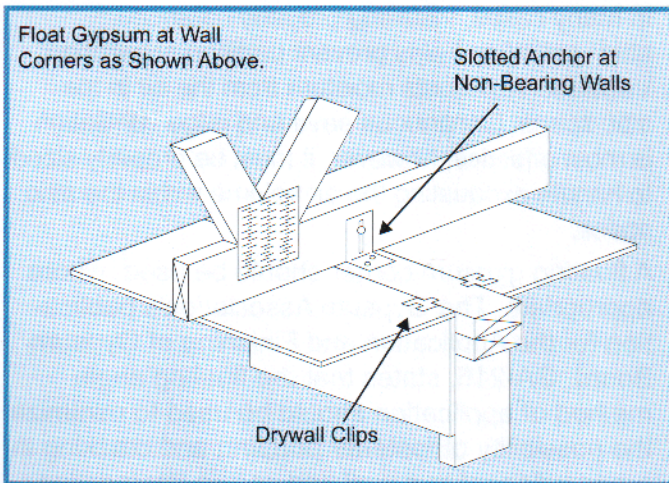
Use of Drywall Clips and Slotted Anchor
on Non-Bearing Wall

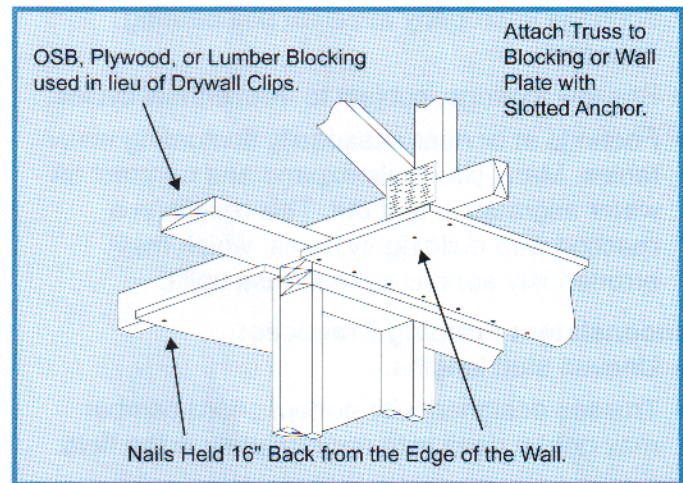
Back Blocking a Gypsum Corner
at Non-Bearing Wall

If this is a fire endurance assembly, see assembly details for the proper gypsum board nail or screw spacing.
